Fortress Dömitz

STRUCTURAL ELEMENT: SANDSTONE PORTAL

Documentation of a Restoration and Repair Project

Baltic Fort Route

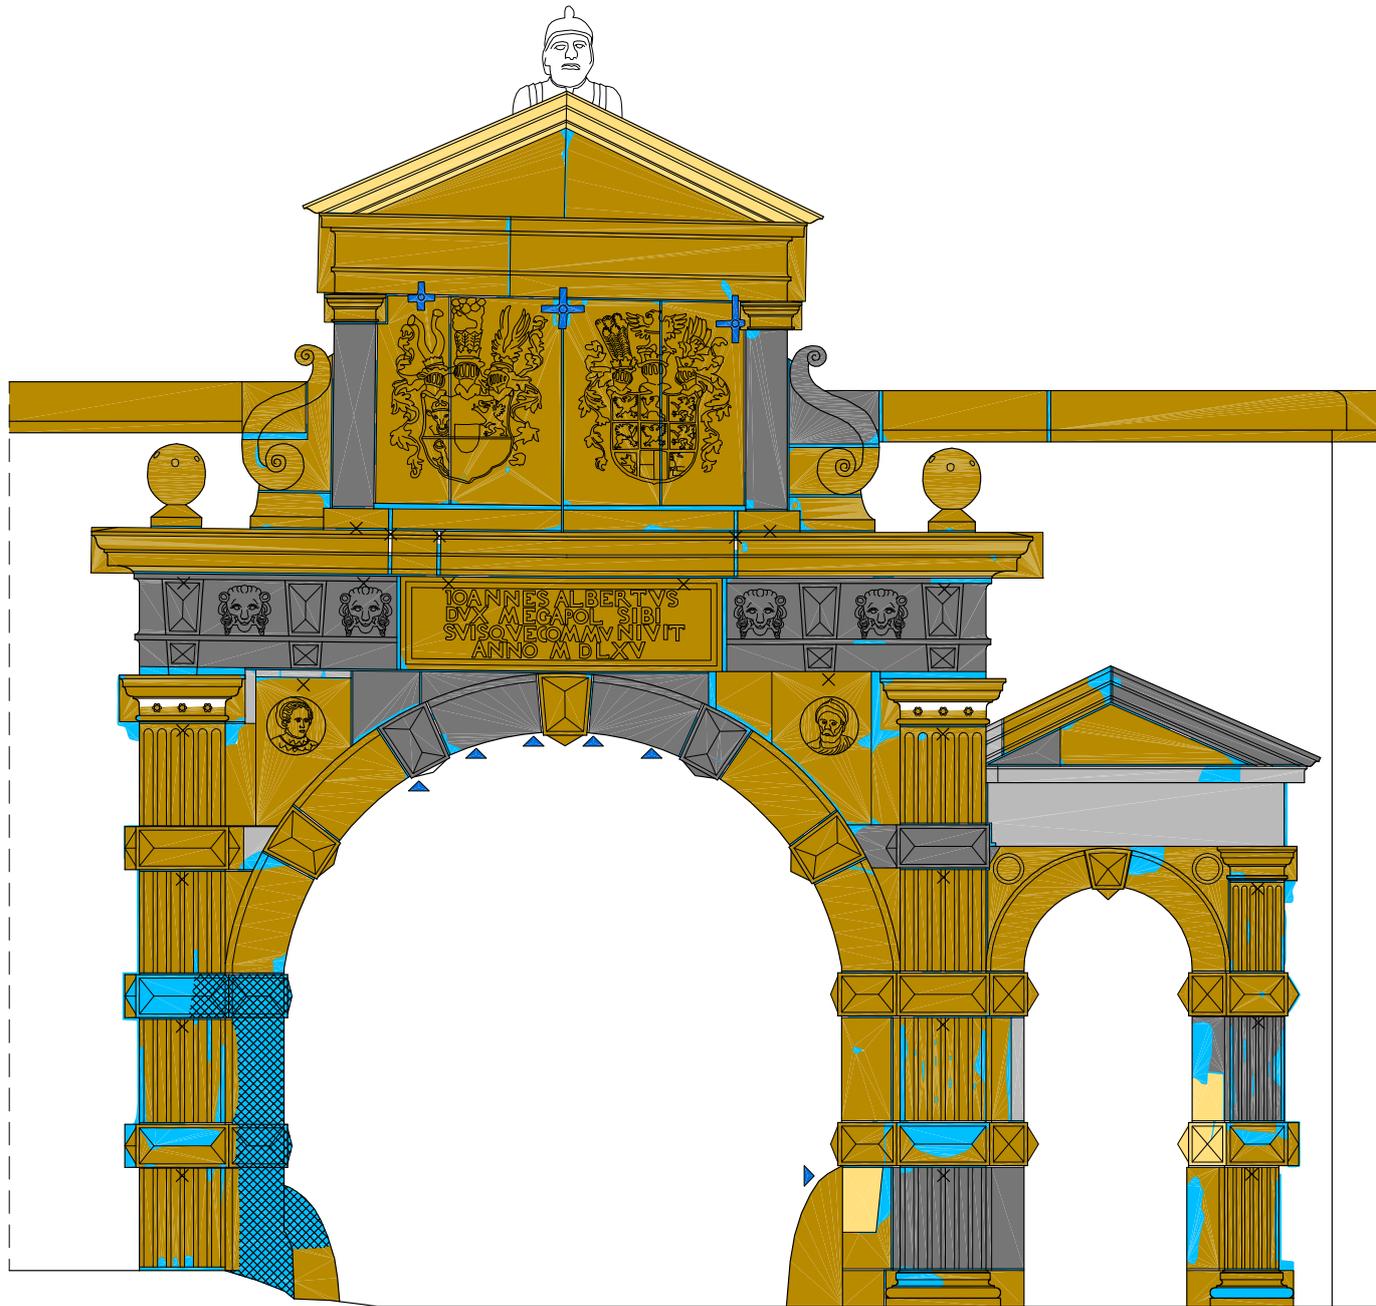
DÖMITZ FORTRESS
SANDSTONE PORTAL
MATERIAL MAPPING 2005

TYPE OF MAPPING		SITE	OBJECT	STRUCT. ELEMENT/AREA
MATERIAL MAPPING		DÖMITZ FORTRESS	SANDSTONE PORTAL	VIEWS
COLOUR	SYMBOL			
		COTTA SANDSTONE, GREY		
		COTTA SANDSTONE, YELLOW		
		POSTA SANDSTONE, YELLOW, BANDED		
		POSTA SANDSTONE, GREY, FOSSIL-CONTAINING		
		MORTAR ON BRICKWORK		
		REPAIR MORTAR		
		VISIBLE IRON ELEMENTS		
		DETECTED IRON ELEMENTS

The locations of the anchors were determined using a metal detector and recorded on the Material Mapping. The anchoring system for the lower portion of the portal was found to be relatively evenly distributed. Every masonry unit of the gateway jambs and the cornice above them is secured by at least one anchor.

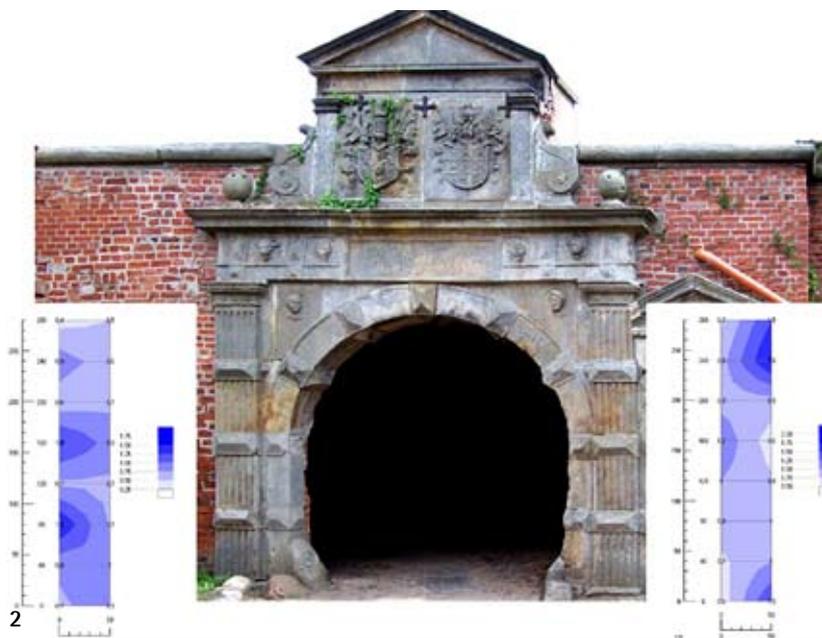
Fig. 2 - Measured moisture content of the pilaster sandstone left and right of the gateway. The high values measured in the upper right section can be attributed to water run-off from the side pediment.

Measurements taken on the brickwork revealed high moisture content in all sections of the wall up to a height of approx. 1.40 m; the moisture content for some areas was found to be at near saturation. This moisture is most certainly the result of rising damp from the ground. Measurements taken on the sandstone pilasters showed a similar condition. Here, however, we must assume that the moisture is migrating from the adjoining brickwork beside and behind the sandstone.

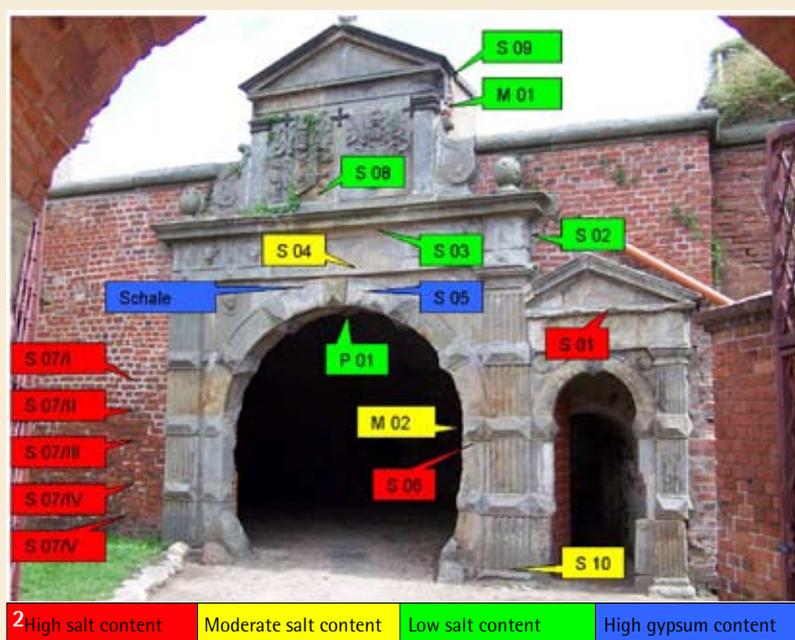
The salt analyses revealed that the salt content of the portal sandstone varies greatly. The area above the archway, for example, was found to have a salt content near zero, while a high content of structurally damaging salts was found in the jambs and pilasters owing to rising damp from the adjacent brickwork.

Fig. 2 - Mapping of the collected samples and their salt content

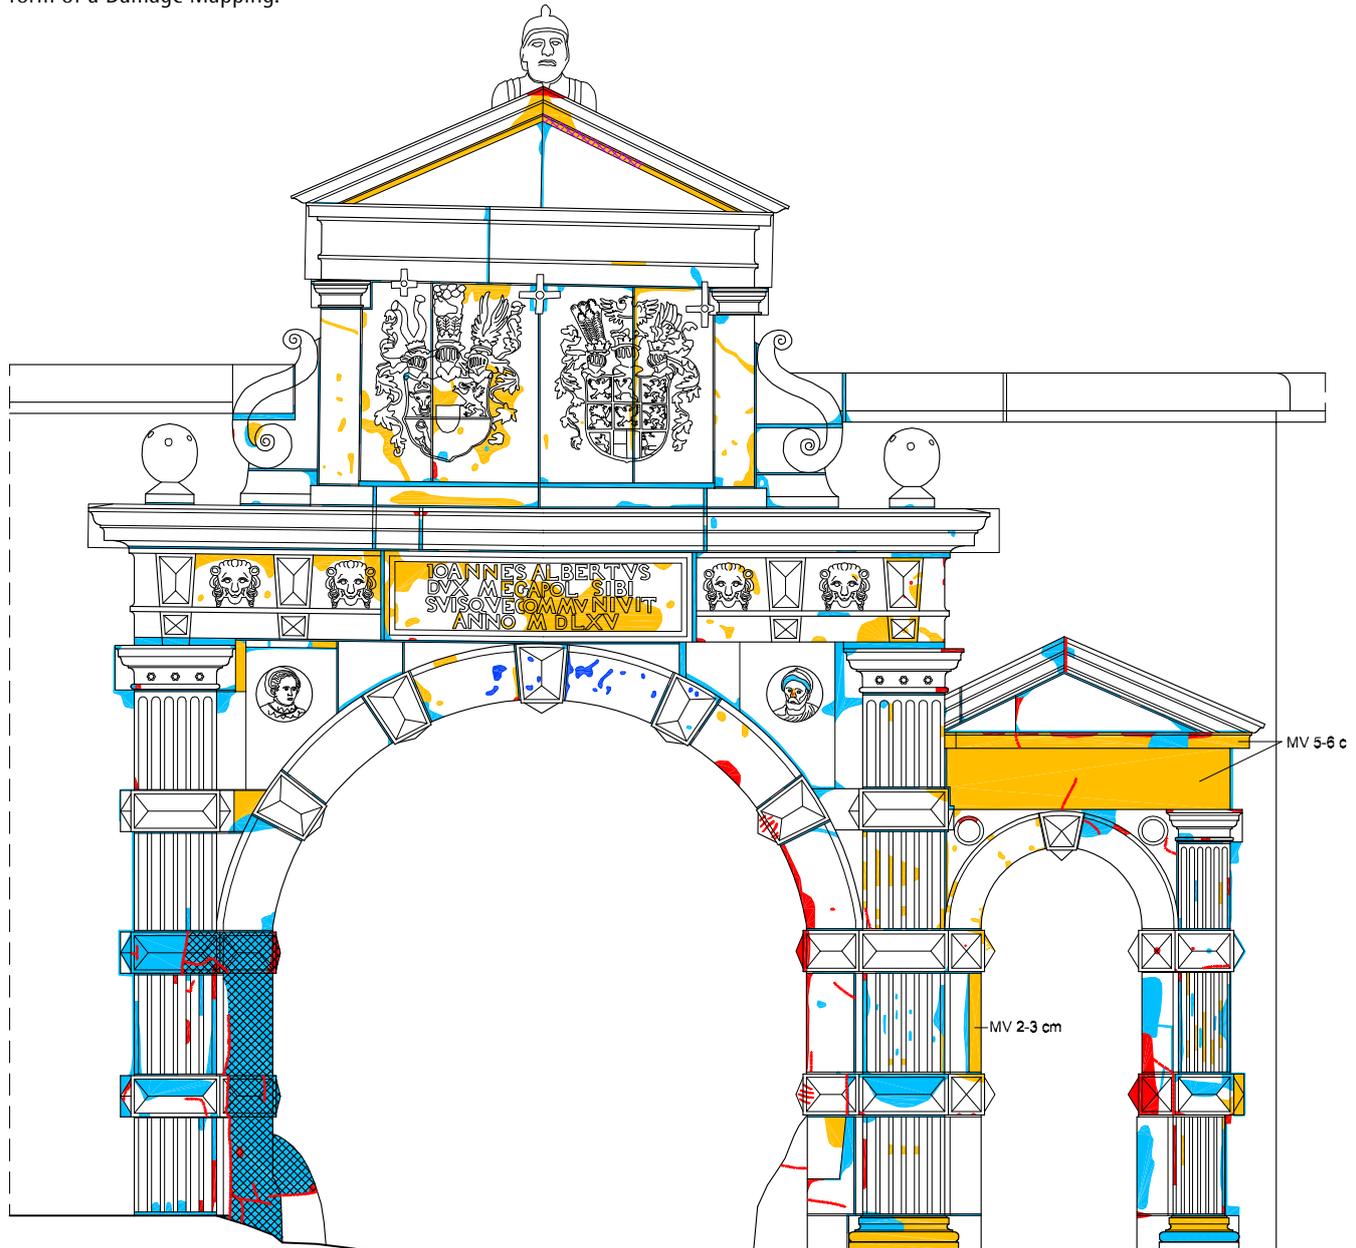
Below - Damage Mapping

Along with the damage closely associated with the moisture and salt content of the sandstone numerous other types of damage were observed during the preliminary investigation. All observed damage was documented in the form of a Damage Mapping.

TYPE OF MAPPING		SITE	OBJECT	STRUCT. ELEMENT/AREA
DAMAGE MAPPING		DÖMITZ FORTRESS	SANDSTONE PORTAL	VEWS
COLOUR	SYMBOL			
[Red]		BREAK OUT / FLAWS		
[Blue]	[Red wavy line]	CRACKS		
[Yellow]		GRANULAR DISINTEGRATION		
[Blue]		CONTOUR SCALING		
[Purple hatched]		CRUSTS		
[Light blue]		REPAIR MORTAR		
[Dark blue hatched]		MORTAR ON BRICKWORK

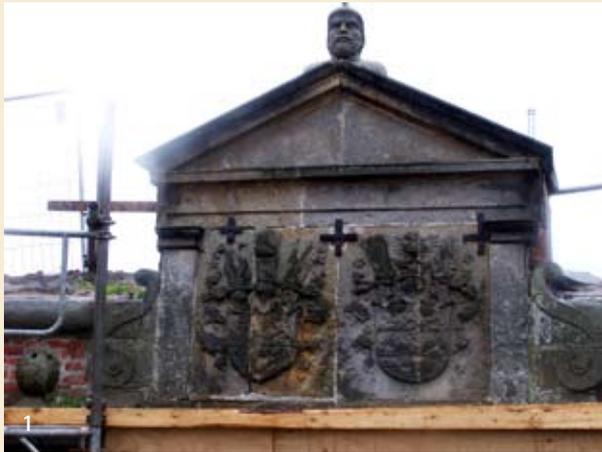
Fig. 1 - Soiling and blackening on the surface of the sandstone

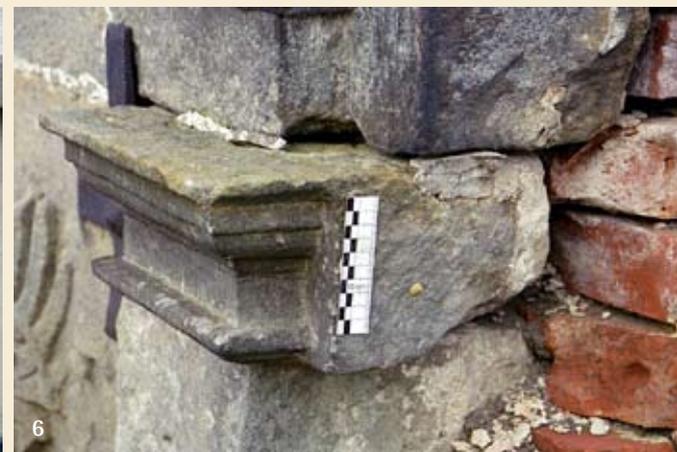
Fig. 6 - Displaced masonry units of the pilaster beside the coat-of-arms relief

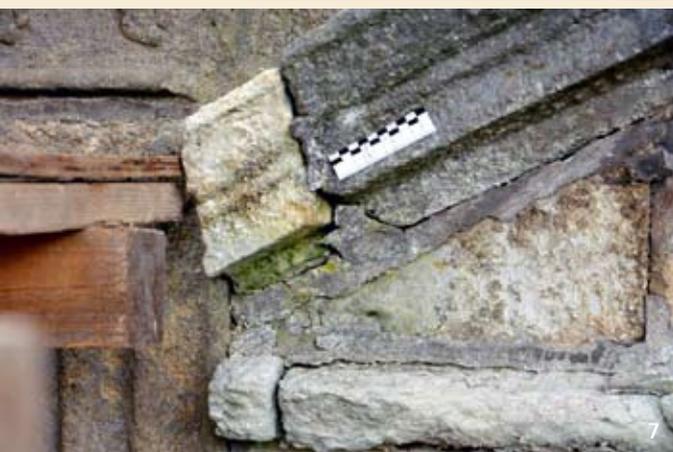
Fig. 7 - Differential erosion and damaged stone graft on the side pediment

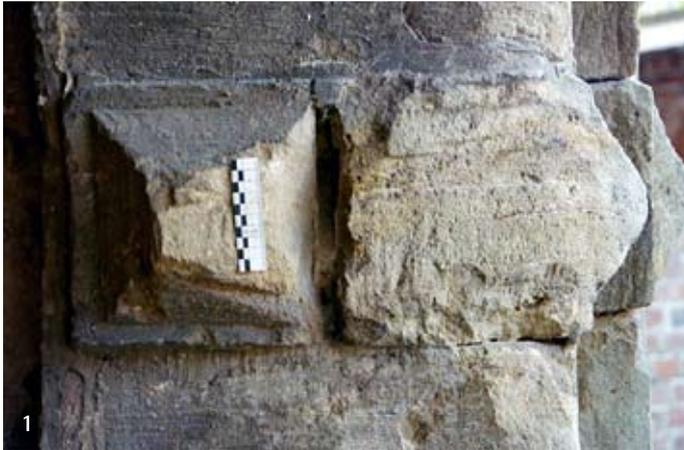
Fig. 1 - Break outs on the right jamb of the gateway caused by vehicles

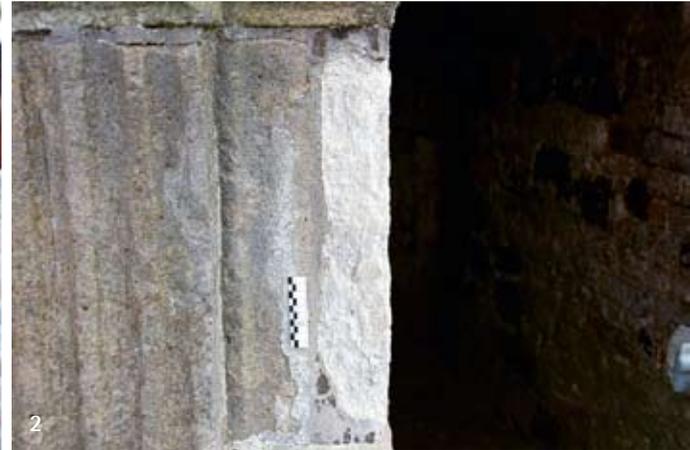
Fig. 2 - Broken off section of repair material

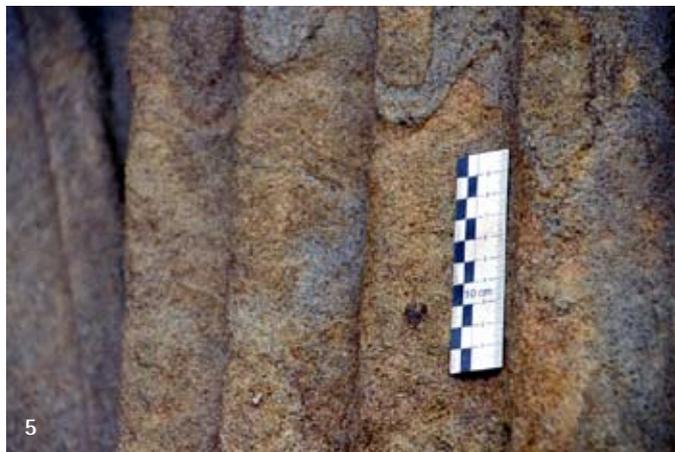
Fig. 5 - Granular disintegration on the surface of a pilaster section

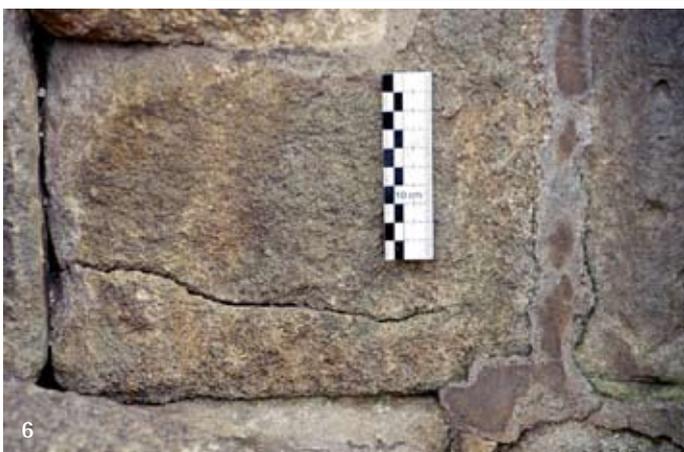
Fig. 6 - Crack formation

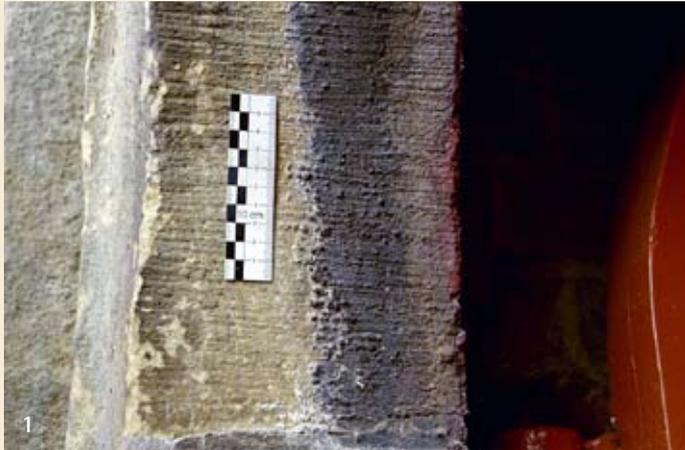
Fig. 1 - Crust formation on the lower surface of the arch

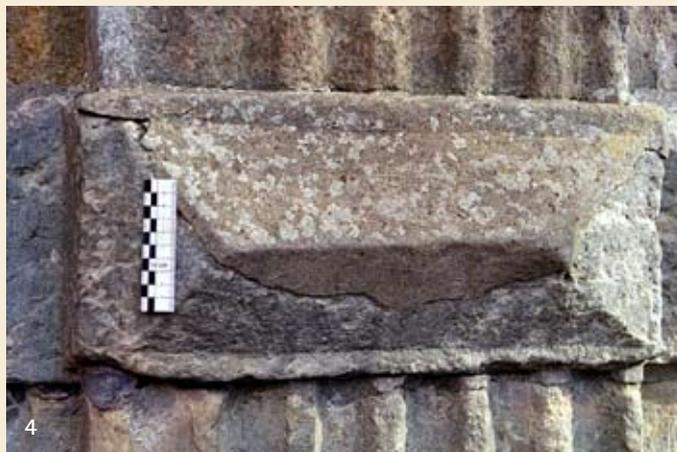
Fig. 4 - Cracks in mortar repair work

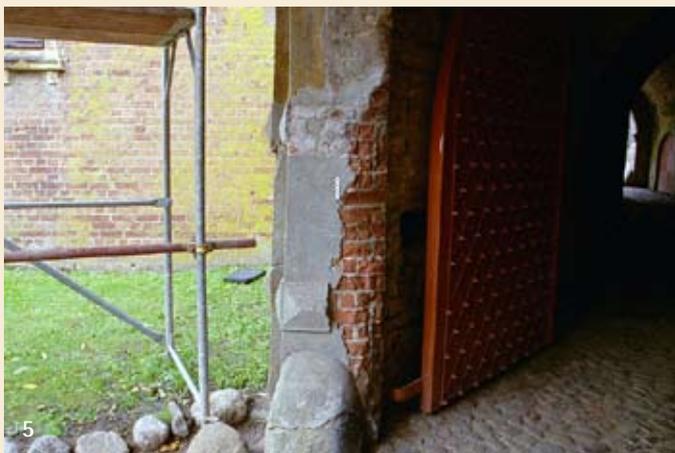
Fig. 5 - Damaged repair work on the left jamb of the gateway

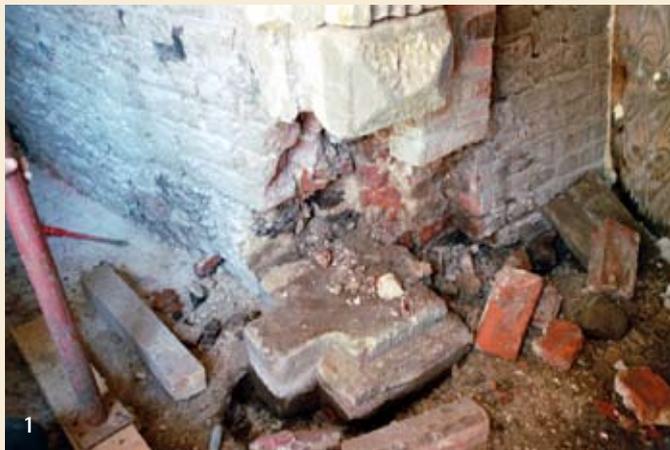
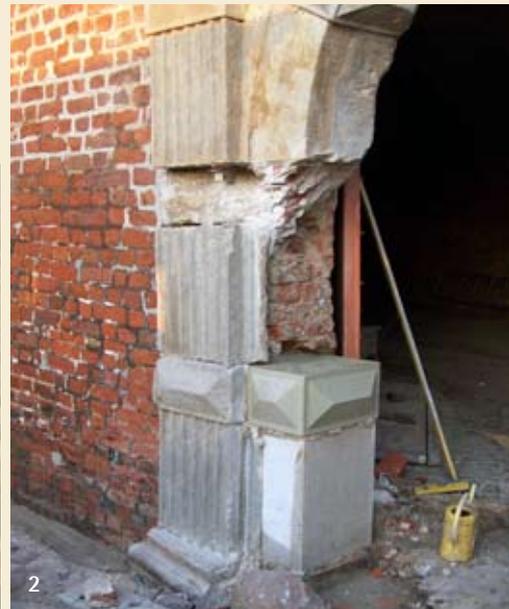
Figs. 1/2 - Left jamb following the removal of old stone grafts and cement-mortar repairs

During earlier restoration work on the portal large flaws were repaired with stone grafts or filled in with plastered brickwork. Cotta-type Elbe sandstone was used for the stone grafts. The properties, in particular the weathering properties, for this type of sandstone differ greatly from those of the sandstones used for the original structure (Posta-type Elbe sandstones). All of the stone grafts made from Cotta sandstone were already showing signs of significant weathering damage.

These stone grafts, as well as the plastered brickwork, were removed and replaced with newly fabricated stone grafts.

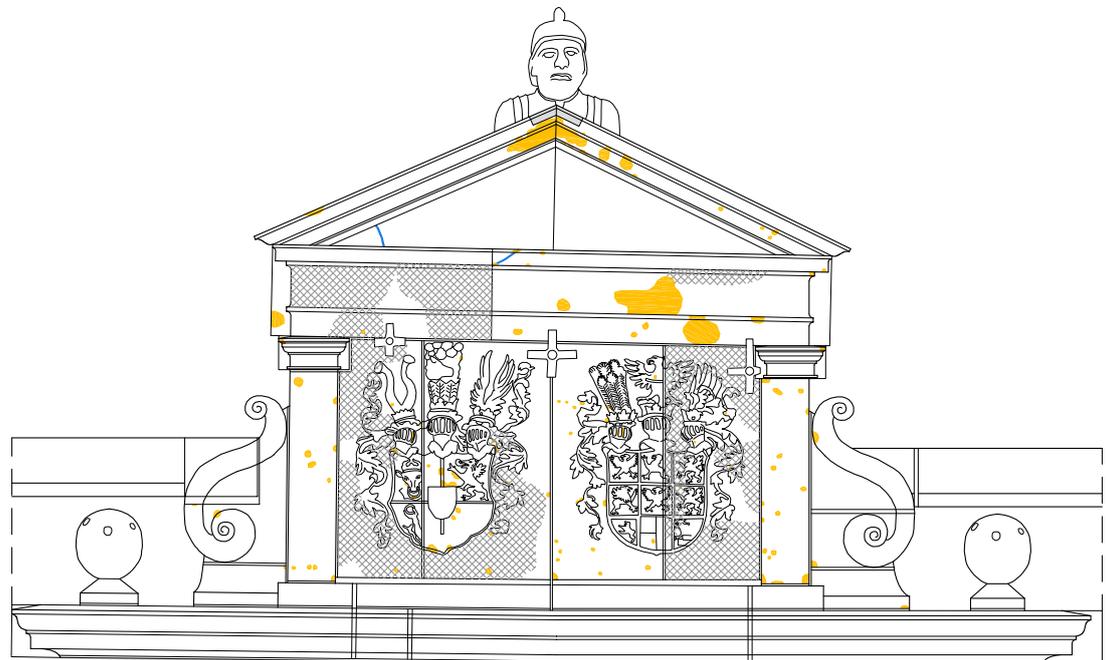
Fig. 4 - Restoration Measure Mapping for the top section of the portal

TYPE OF MAPPING		SITE	OBJECT	STRUCT. ELEMENT/AREA
RESTORATION MEASURE MAPPING		DÖMITZ FORTRESS	SANDSTONE PORTAL	VEWS
COLOUR	SYMBOL			
[Yellow]	[None]	PATCHING WITH STONE REPAIR COMPOUNDS (SAE BINDER)		
[Purple]	[None]	PATCHING WITH STONE REPAIR COMPOUNDS (CALCITIC BINDER)		
[Blue]	[None]	RECEMENTING OF BROKEN PIECES		
[Red]	[None]	CRACK REPAIR		
[Hatched]	[None]	AREAS STRENGTHENED WITH SAE		
[Grey]	[None]	STONE GRAFT
