Fortress Dömitz

STRUCTURAL ELEMENT: SANDSTONE PORTAL

Documentation of a Restoration and Repair Project

Baltic Fort Route

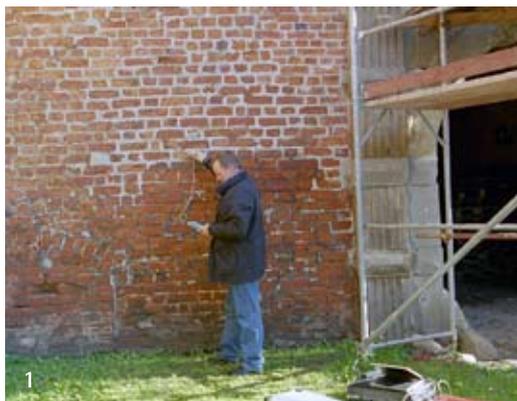
Fig. 2 - Measured moisture content of the pilaster sandstone left and right of the gateway. The high values measured in the upper right section can be attributed to water run-off from the side pediment.

Measurements taken on the brickwork revealed high moisture content in all sections of the wall up to a height of approx. 1.40 m; the moisture content for some areas was found to be at near saturation. This moisture is most certainly the result of rising damp from the ground. Measurements taken on the sandstone pilasters showed a similar condition. Here, however, we must assume that the moisture is migrating from the adjoining brickwork beside and behind the sandstone.

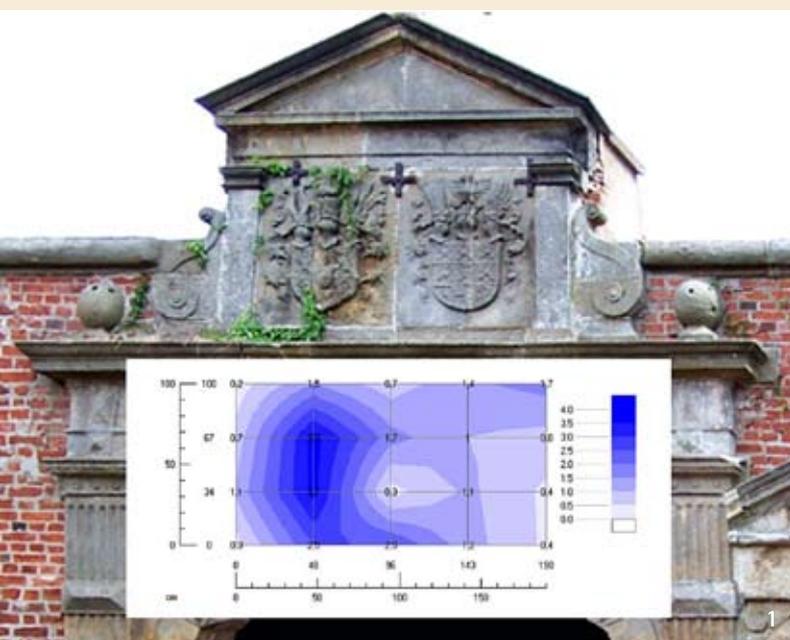
The salt analyses revealed that the salt content of the portal sandstone varies greatly. The area above the archway, for example, was found to have a salt content near zero, while a high content of structurally damaging salts was found in the jambs and pilasters owing to rising damp from the adjacent brickwork.

Fig. 1 - Measurements taken in the coat-of-arms area of the top portal section

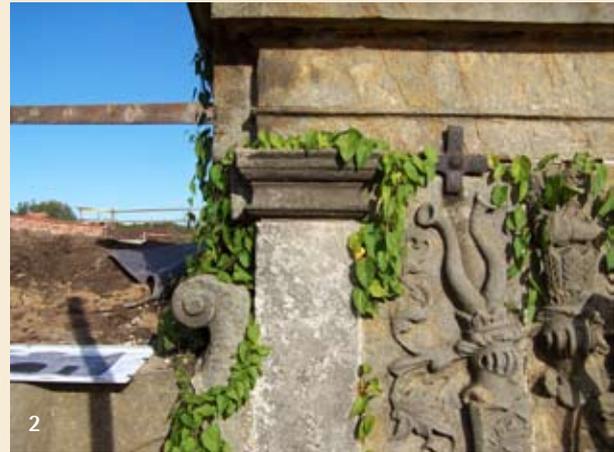
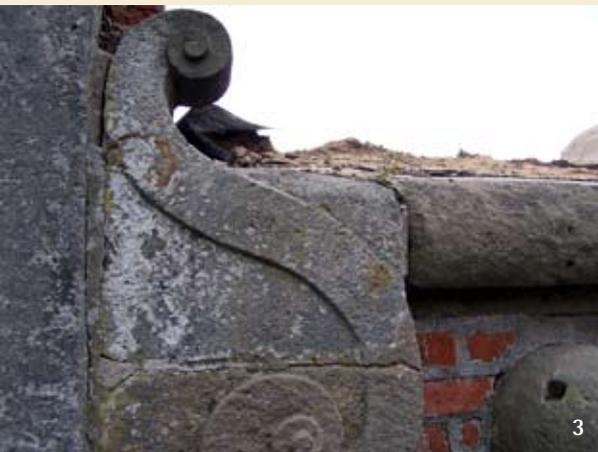
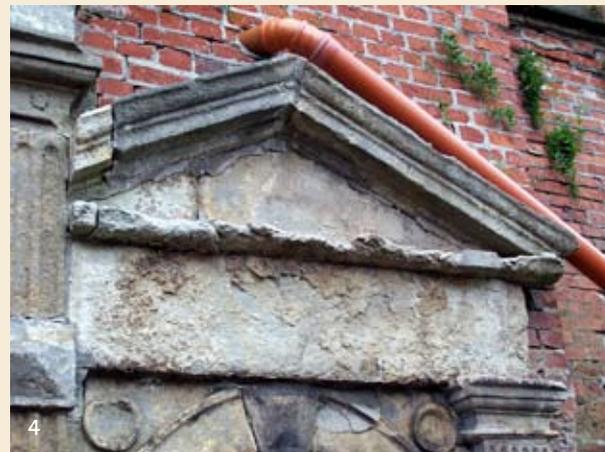
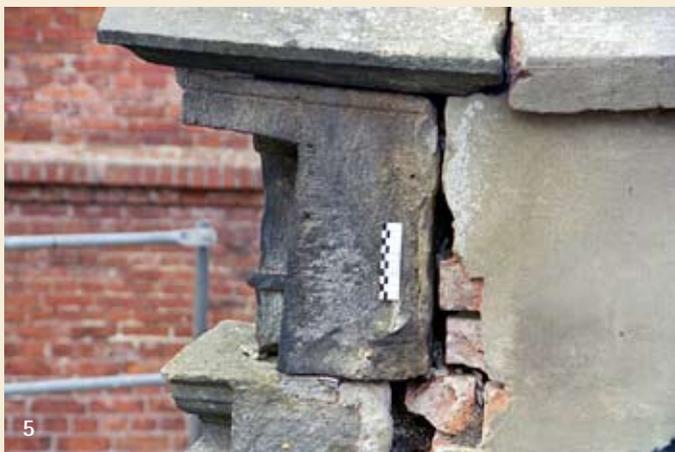
Fig. 1 - Soiling and blackening on the surface of the sandstone

Fig. 5 - Displacement in the top section of the portal above the gateway

Fig. 6 - Displaced masonry units of the pilaster beside the coat-of-arms relief

Fig. 7 - Differential erosion and damaged stone graft on the side pediment

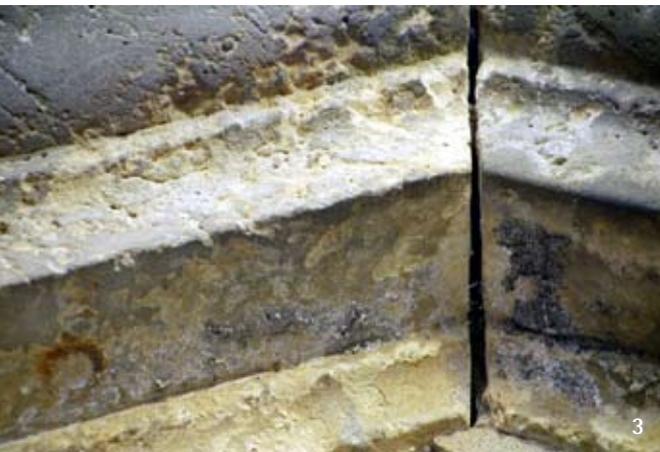
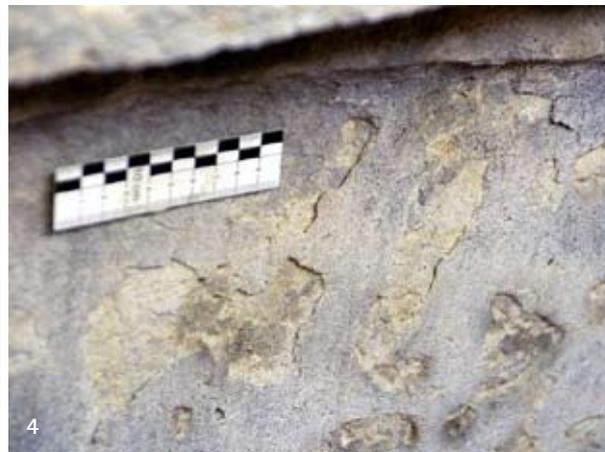
Fig. 5 - Granular disintegration on the surface of a pilaster section

Fig. 6 - Crack formation

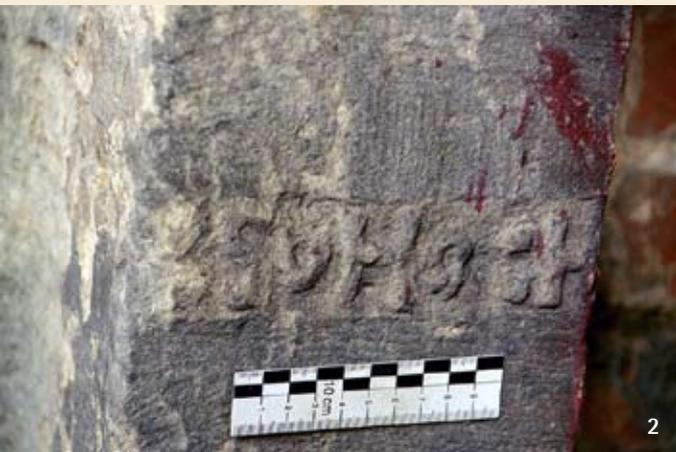
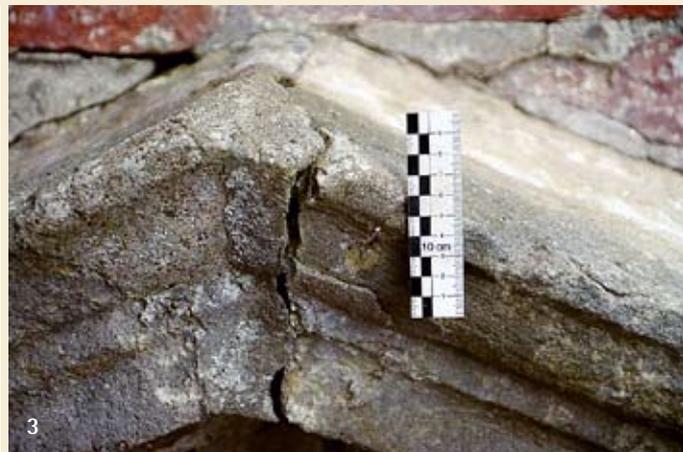
Fig. 4 - Cracks in mortar repair work

Fig. 5 - Damaged repair work on the left jamb of the gateway

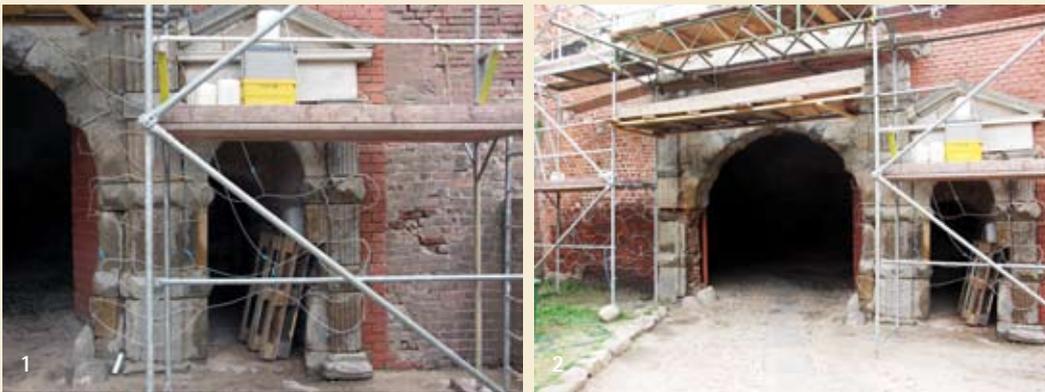
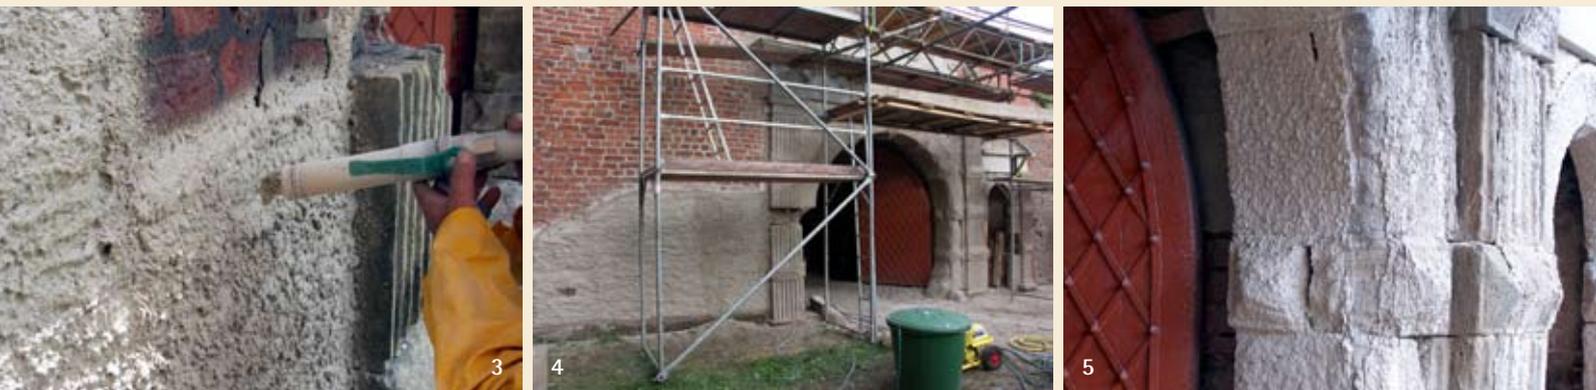
The sandstone blocks which form the pilasters and the jambs on either side of the gateway and side entrance were found to have high salt contents in some parts. The identified salts were a mixture of various nitrates and chlorides. Furthermore, along with gypsum, a relatively high sodium sulphate content was detected in some areas. This type of salt known to be especially damaging to building materials.

Fig. 3 - Application of desalination poultice

A salt-reduction treatment was carried out using a desalination poultice. This treatment is based on the transportation of salts from the rock into the poultices by means of a directed flow of moisture. For this purpose the treated stone is irrigated through integrated tubing from a water supply tank.

The poultice material is sprayed onto the cleaned surfaces of the sandstone and adjacent brickwork using a small plastering machine.

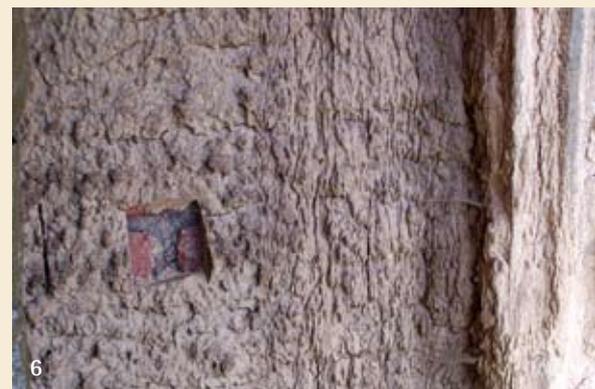
Fig. 6 - Sample removed for evaluating success of desalination treatment

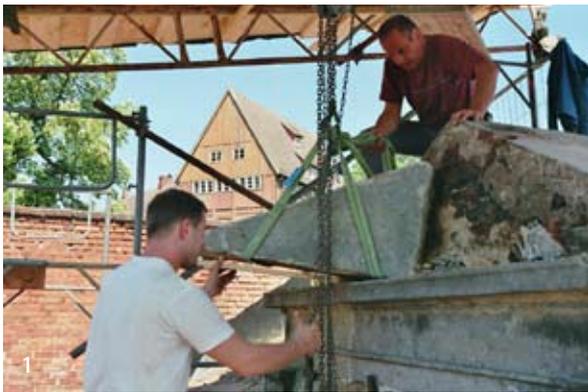
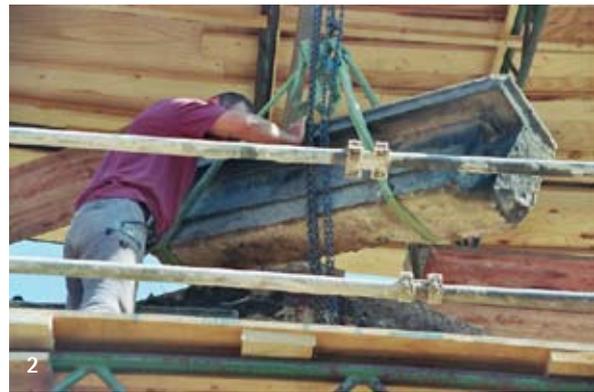
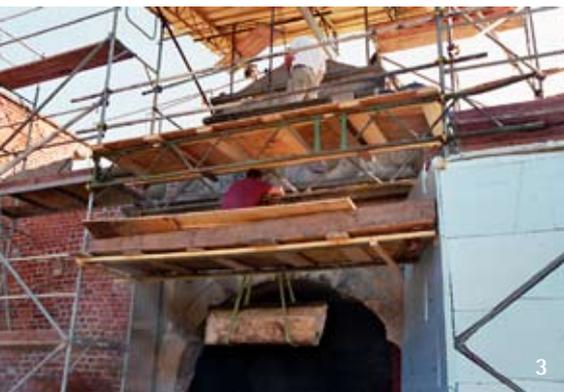
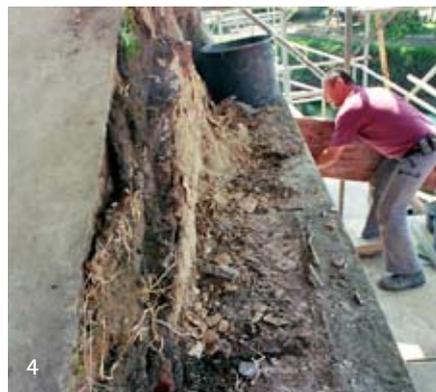
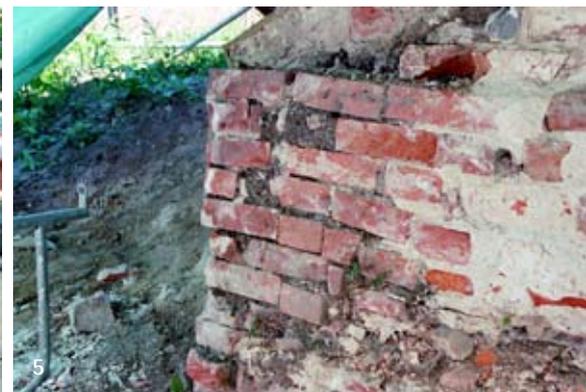
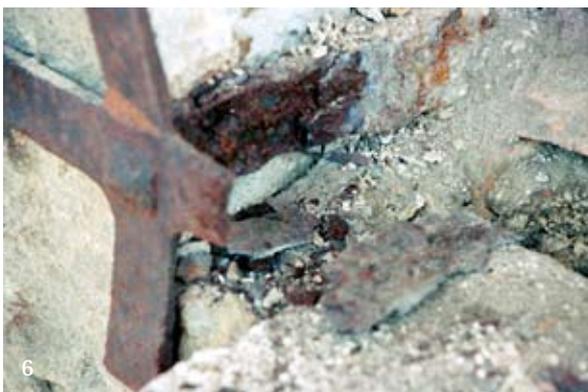
The masonry units of the coat of arms cartouche above the gateway, with the flanking volutes and the pediment, exhibited displacements of up to 4 cm. As a result of this displacement large gaps had formed between the masonry units and the brick wall behind them as well as in the joints between stones. These gaps had filled with humus. Plants were growing in this humus, and their roots were exerting pressure on the masonry units and contributing to additional displacement of the structure.

Figs. 1-3 - Dismantling of the pediment above the gateway

Therefore this entire portal section, down to the cornice, was dismantled and the structural elements re-set.

The solid masonry units were initially re-set, or re-laid, without mortar onto sheet-lead spacers. The masonry units were stabilised with anchors, braces and dowels made of 316 stainless steel (V4A) or brass. The joints between the masonry units were then sealed with tow (hemp) and filled in with liquid mortar. After the bedding mortar had set the tow was removed and the joints tuck-pointed. The three visible wrought-iron anchors of the coat-of-arms cartouche were restored and refastened.

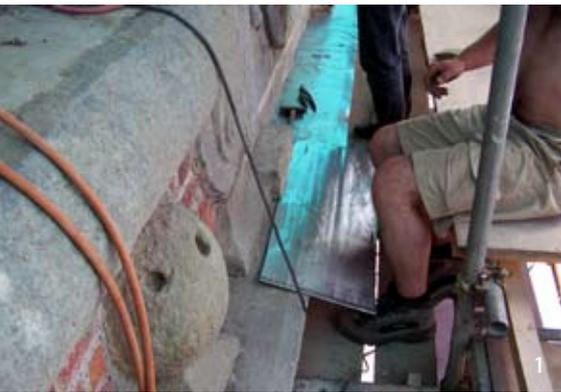
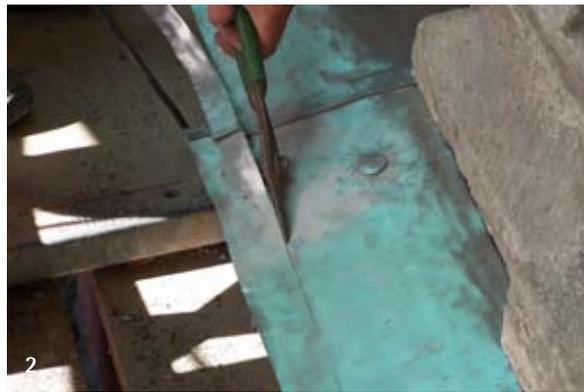
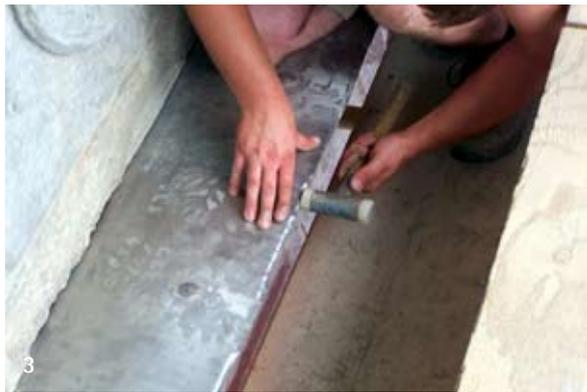
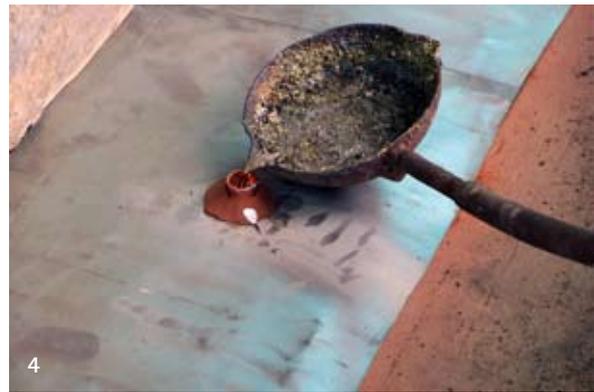
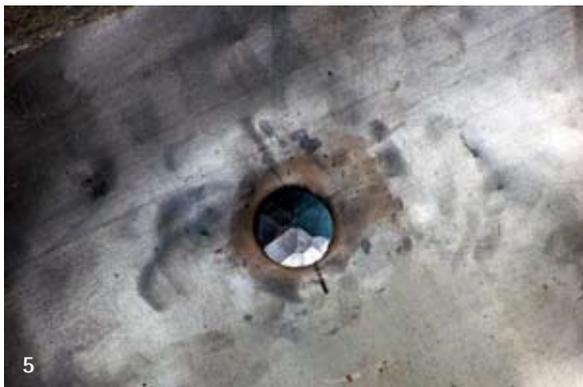
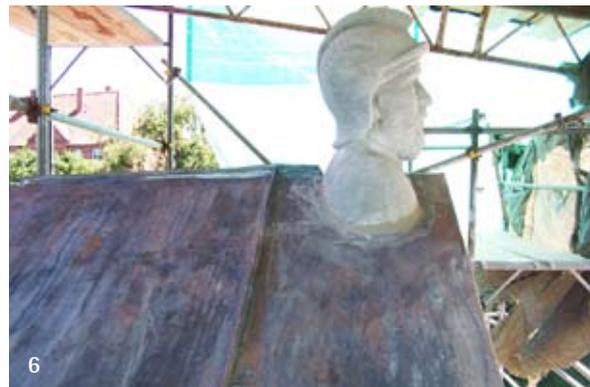
In addition to the rising damp and the moisture migration from the brick wall of the bastion, rainwater penetration was identified as another major cause for the weathering damage experienced by the sandstone structural elements. Therefore the top surfaces of the pediments above the gateway and the side entrance were covered with a layer of sheet lead (1.0 mm) for water run-off. In order to avoid blurring or distorting the profile lines the coverings were formed without locking strips and with a narrow protruding edge (approx. 1 cm).

Figs. 1-3 - Application of the sheeting

Figs. 4/5 - Fastening of the sheeting with traditional melted lead

Fig. 6 - Sheetting on the top surface of the upper pediment

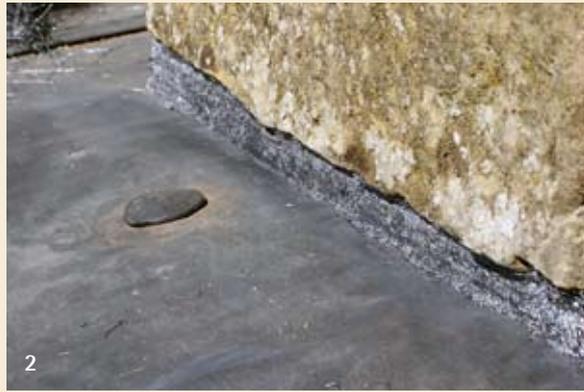
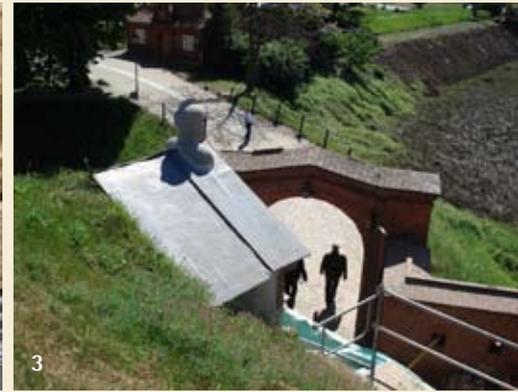
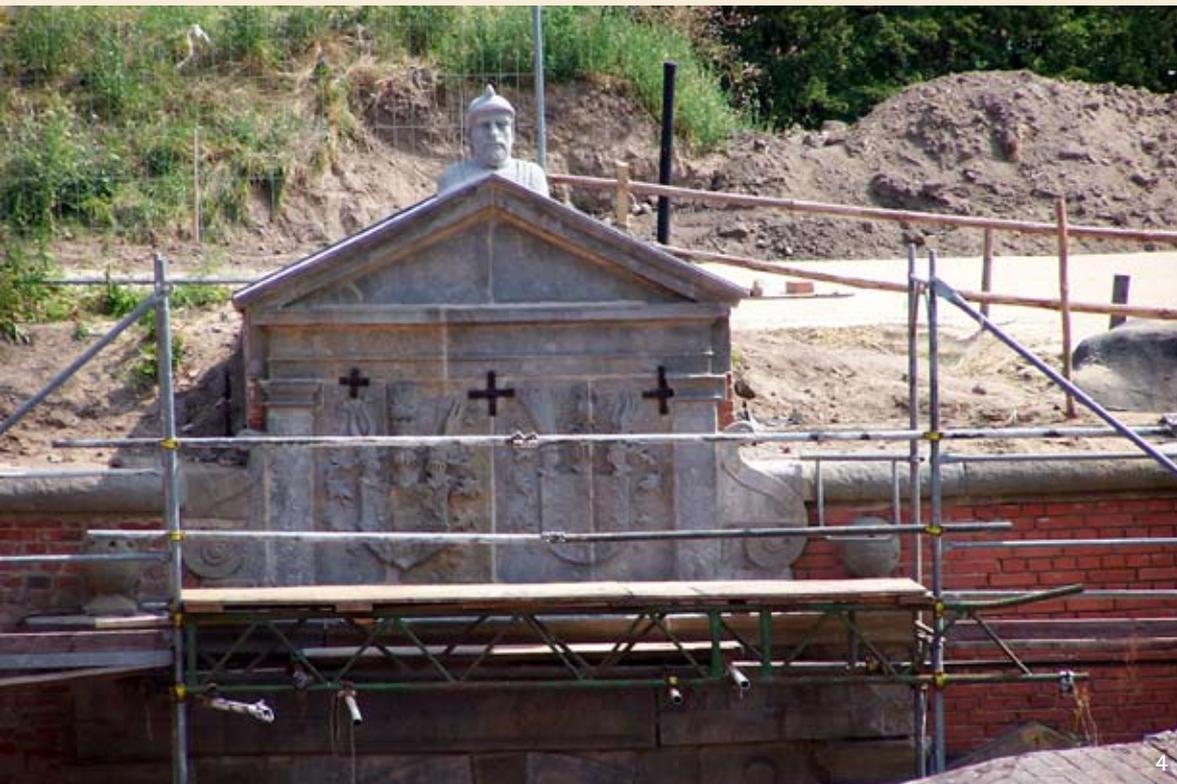
Figs. 1/2 - Sealing of joints with lead wool

Fig. 3 - Pediment with sheeting

Fig. 4 - Pediment above the gateway after re-setting

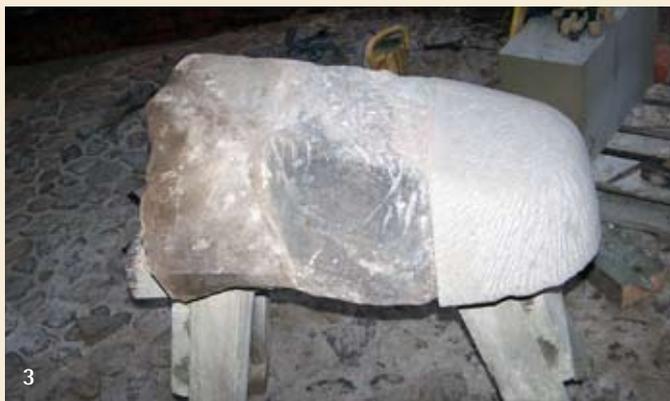
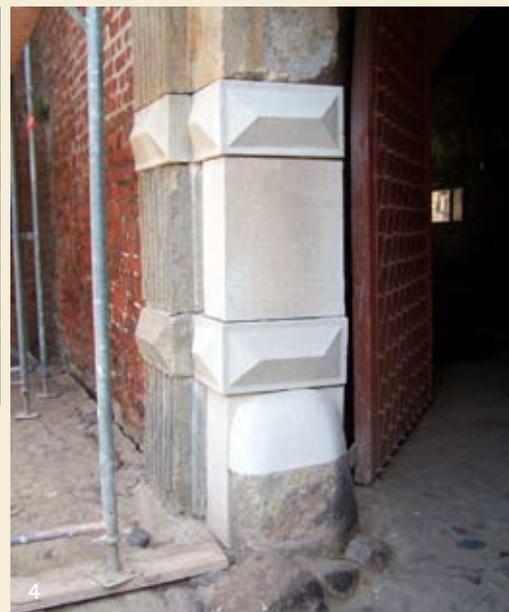
Figs. 1/2 - Left jamb following the removal of old stone grafts and cement-mortar repairs

Fig. 3 - Replacement of the upper section of the guardstone inside the left jamb

Masonry unit replacement implies the complete removal of a masonry element and replacement with a newly fabricated element. This measure was required in the left pilaster of the sandstone portal, on the jamb of the gateway, and on the frieze and lower cornice of the pediment above the side entrance.

The pediment above the side entrance, which was severely displaced and shifted toward the front, had to be completely dismantled down to the vaulted arch for the replacement of damaged masonry units. The usable masonry units were then re-set together with newly fabricated units.

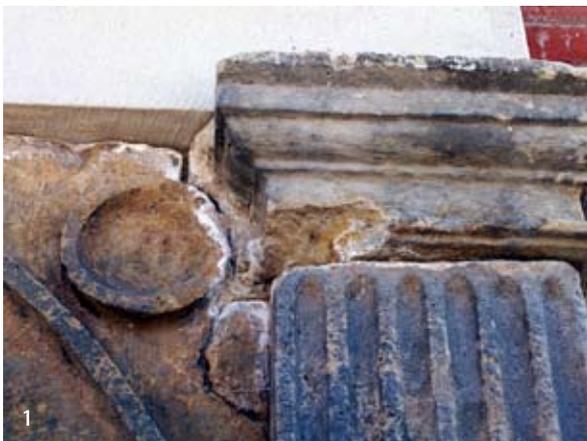
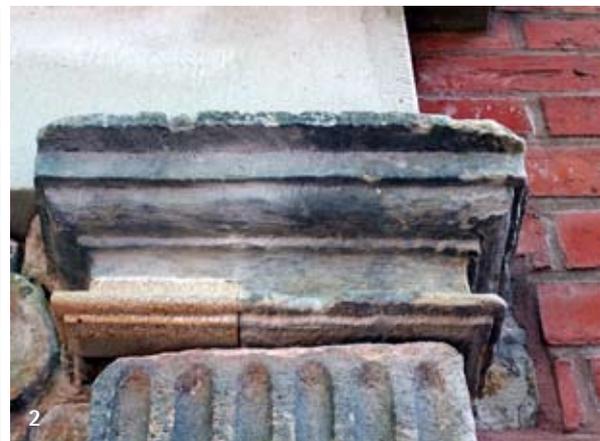
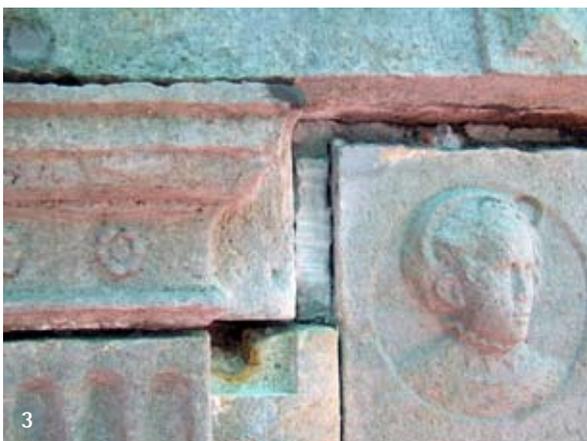
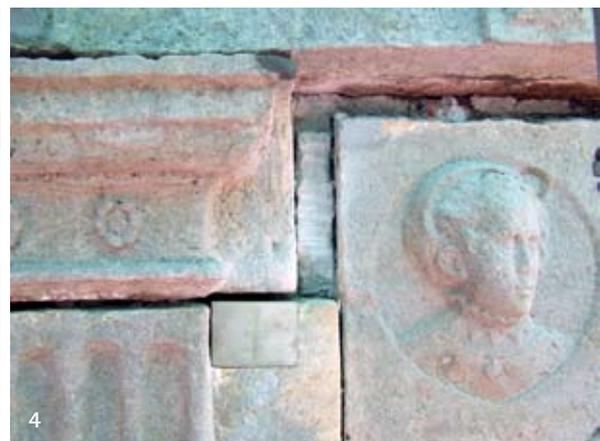
During earlier restoration work on the portal large flaws were repaired with stone grafts or filled in with plastered brickwork. Cotta-type Elbe sandstone was used for the stone grafts. The properties, in particular the weathering properties, for this type of sandstone differ greatly from those of the sandstones used for the original structure (Posta-type Elbe sandstones). All of the stone grafts made from Cotta sandstone were already showing signs of significant weathering damage.

Figs. 1-4 - Stone grafts on pilaster and in the architrave area

These stone grafts, as well as the plastered brickwork, were removed and replaced with newly fabricated stone grafts.

The new stone grafts were made from Posta-type sandstone from the Mühlleite quarry; the macroscopic and physico-mechanical properties of this sandstone were found to be very similar to the sandstone of the original structure.

The stone grafts were dimensioned using traditional stonemasonry techniques, i.e. without sawn surfaces or profiles. The surfaces of the grafts were prepared using techniques similar to those used for the existing masonry units; for most of this work hand-forged tools were used. The stone grafts were fastened with dowels made of 316 stainless steel (V4A) and aligned using lead spacers, depending on the specific requirements of the repair. The joints were grouted and tuck-pointed with a hydraulic lime mortar.

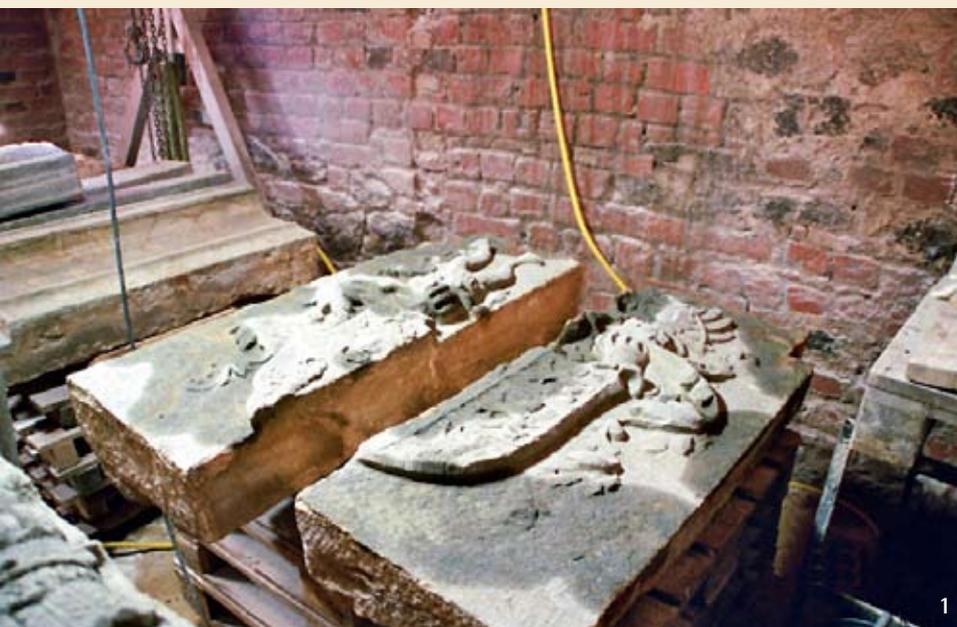
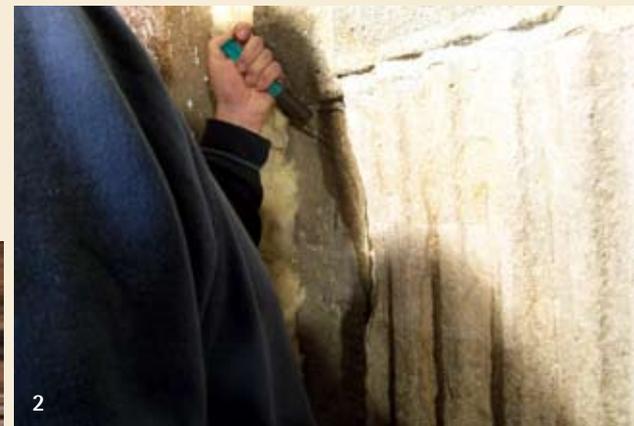
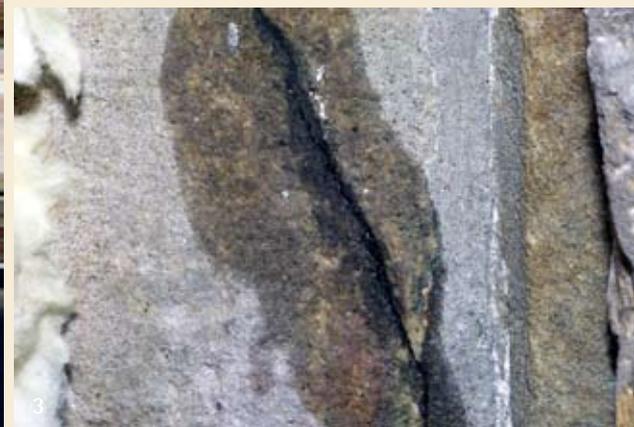
Fig. 2 - Application of injection material using a syringe

Fig. 3 - Crack following the application of injection material. The discolouration around the crack from the preliminary moistening with silicic acid ester recedes after the ester has fully cured and dried.

An injection mortar composed of silicic acid ester, fillers and glass beads in a fixed ratio was used for filling in smaller cracks and backfilling hollow layers and large scales. The injection mortar was mixed well to disperse individual components and then injected into the cracks and hollow layers with injection syringes; these areas had been pre-moistened with silicic acid ester prior to the application of the injection material. The silicic acid ester is used here as a binder which functions in the same way as in the strengthening treatments: through the secretion of an amorphous silica gel that cements the aggregates together and to the flanks of the cracks.

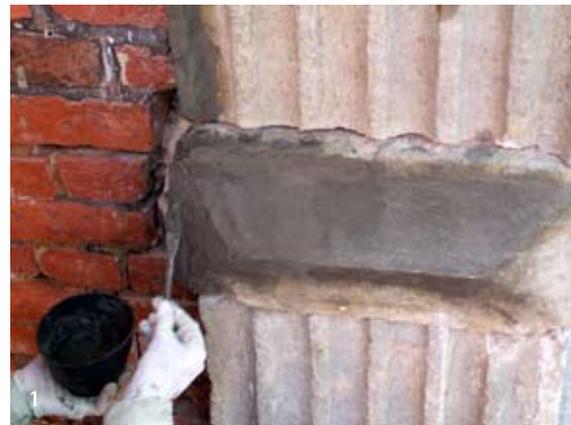
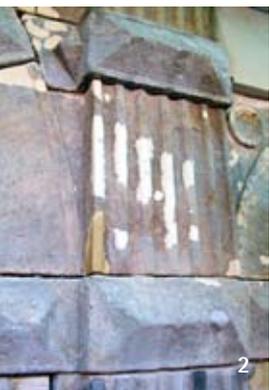
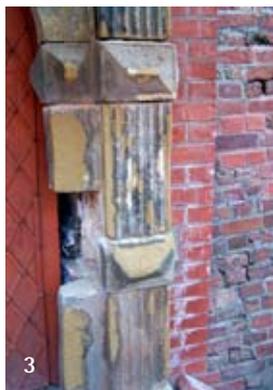
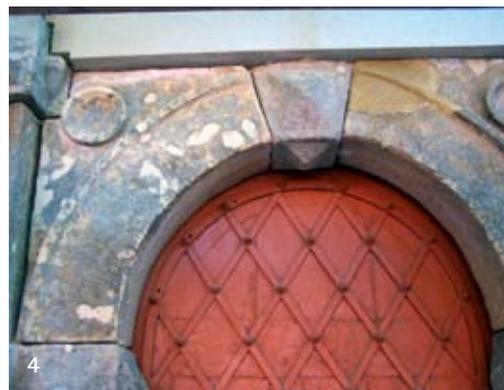
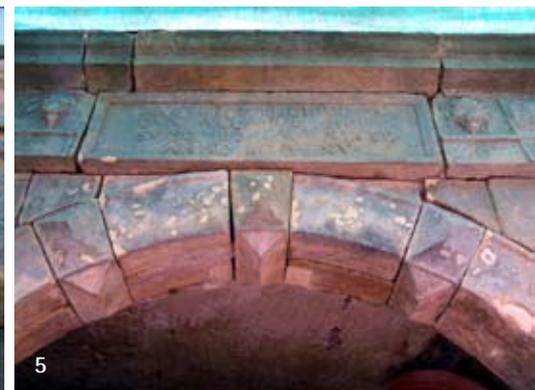
Above and right:
Figs. 1-5 - Patching flaws with
stone repair mortar
Figs. 6/7 - Retouching repair
work

A stone repair compound with a silicic acid ester binder was used for closing small to medium-sized flaws and areas of back-weathering as well as filling in spaces around plates of detached stone and contour scaling. In order to improve the adhesion of the repair mortar the surface of stone to be repaired was pre-moistened with SAE, and a bonding agent was applied.

The patches were made flush with the surface. Shallow flaws only required a single application of material to attain the required level. For larger repairs, however, the material was applied in layers. In this case the surface of the lower layer was roughened before the next layer was applied in order to avoid leaving solid and smooth surfaces which could inhibit proper bonding.

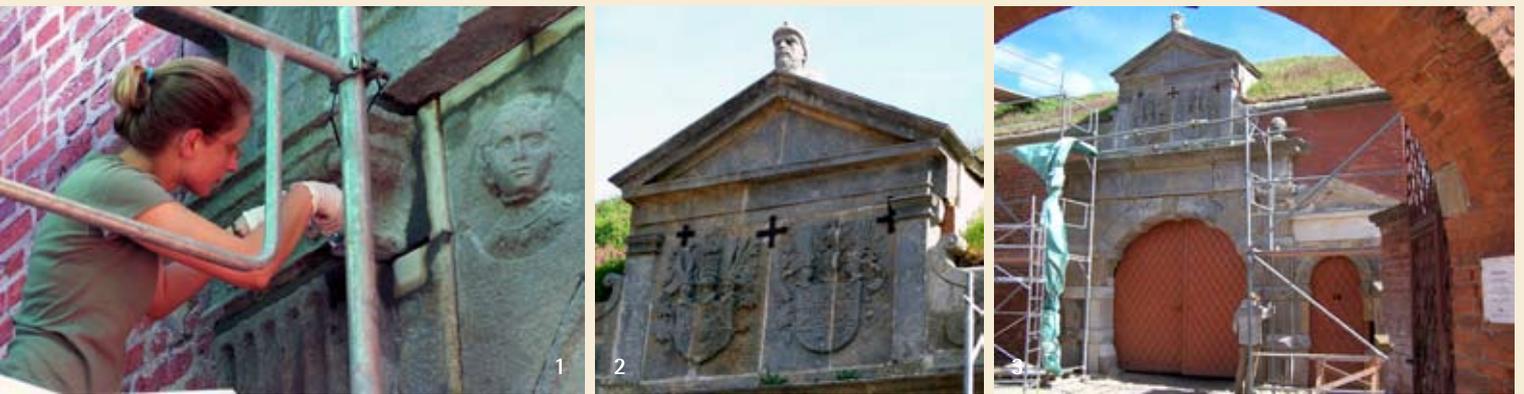
Fig. 1 - Filling of joints with mortar

Fig. 2 - Pediment after completion of repair and jointing work

The earth-moist jointing material was pressed into the joints using pointing irons. After the curing process had begun the material was touched up with a scalpel to make the mortar flush with the surface.

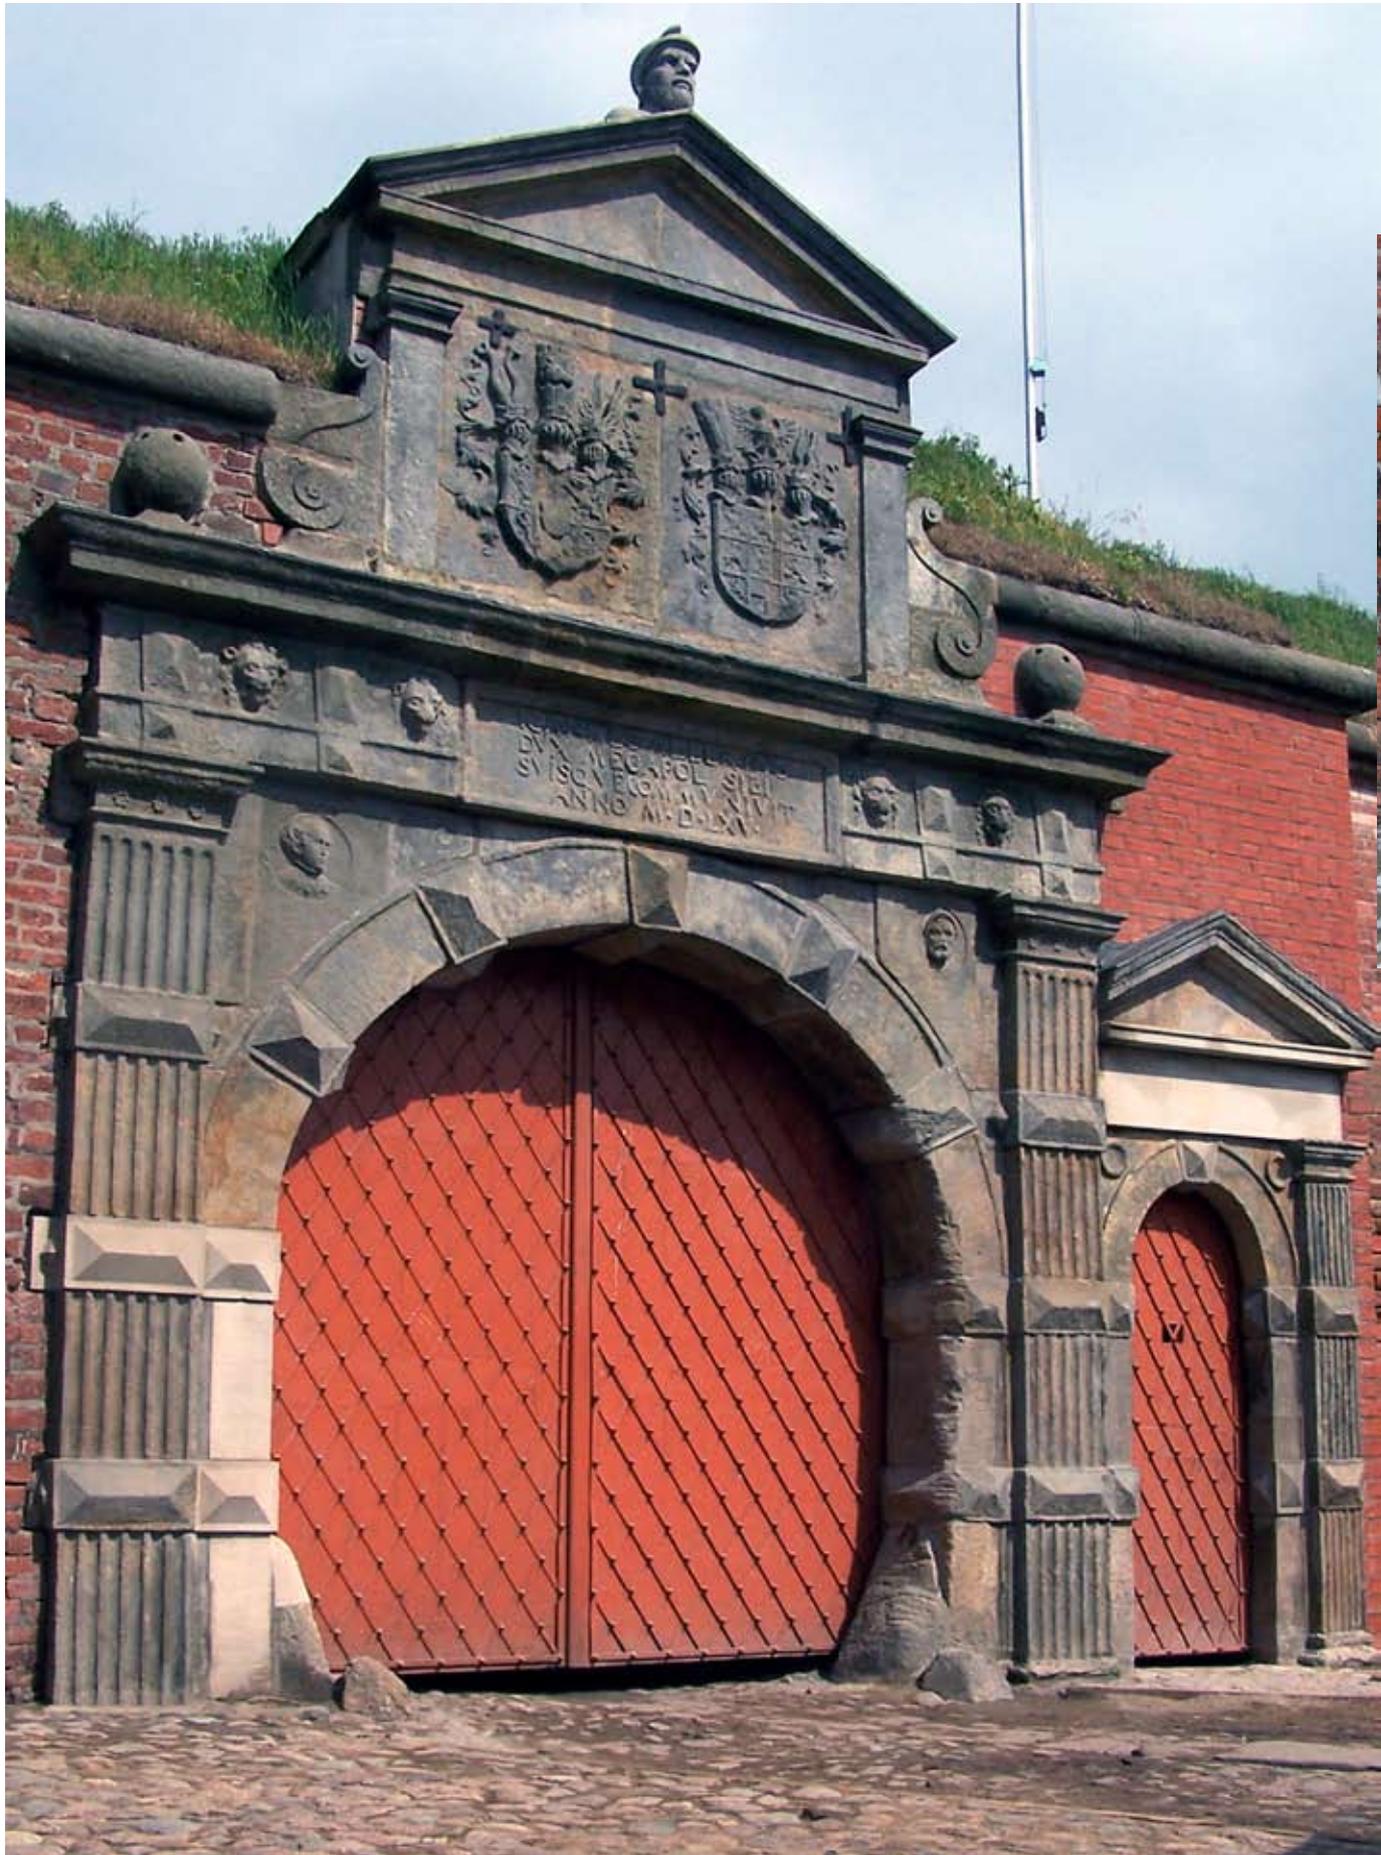
Left - Full frontal view after completion of restoration project

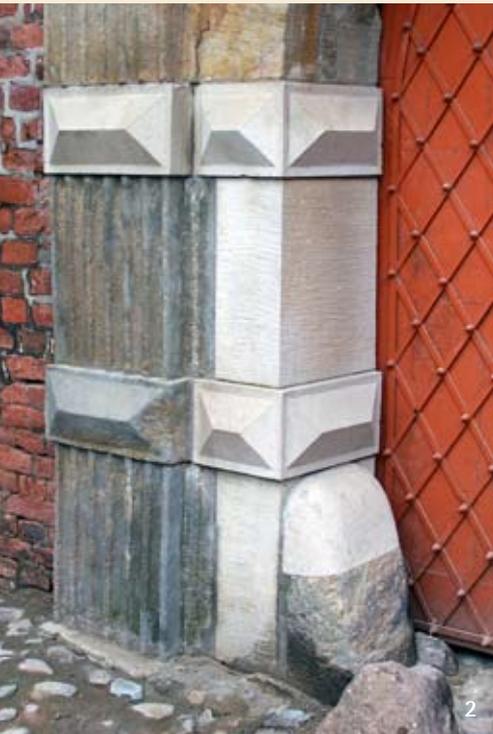
Fig. 2 - Repaired gate jamb

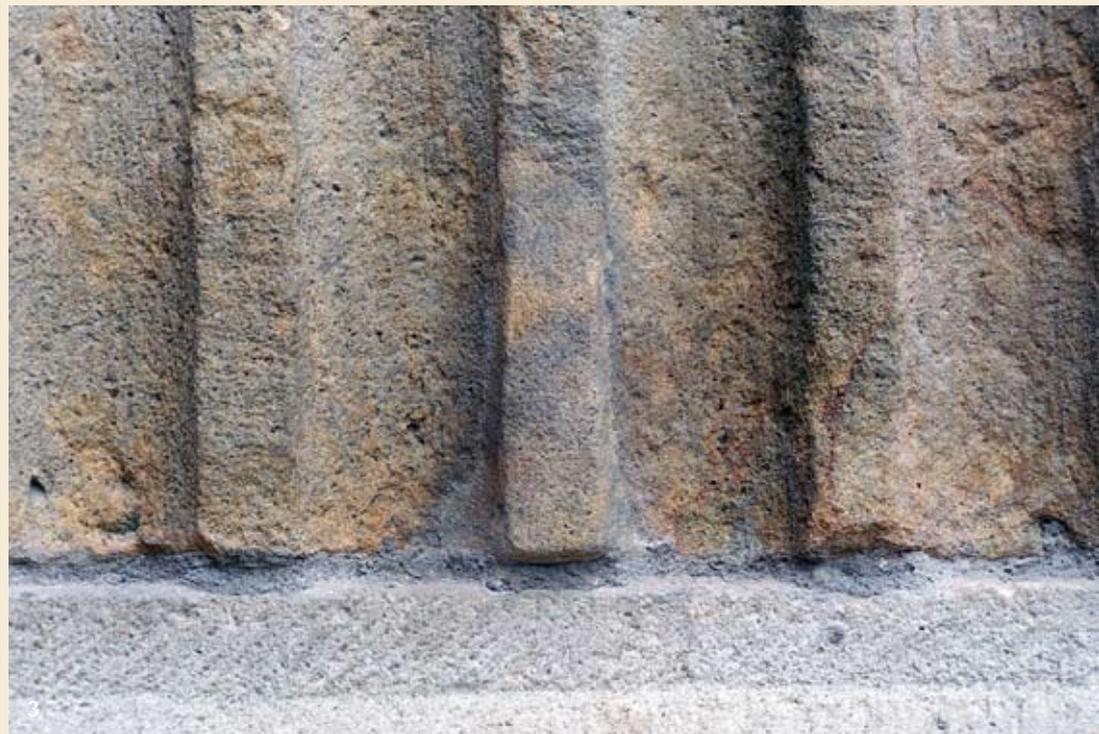
Fig. 3 - Repair work with stone repair compound on the pilaster to the right of the gate

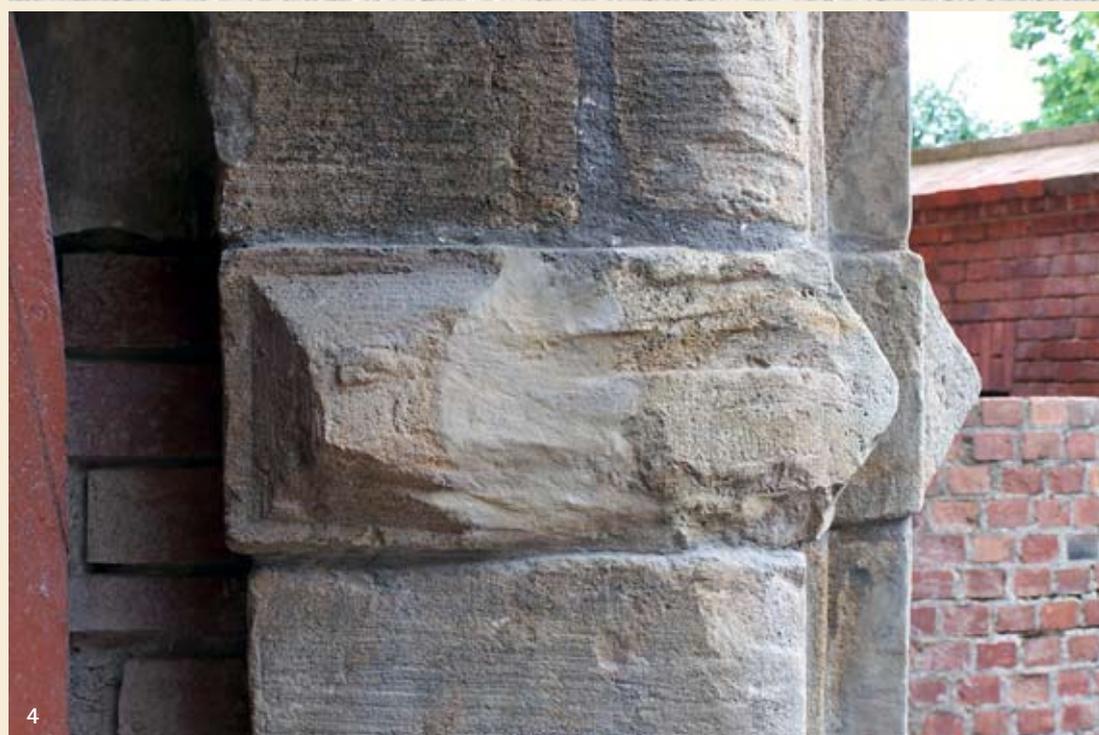
Fig. 4 - "Traces of use" preserved on the jamb of the gateway and conservative repair of break out

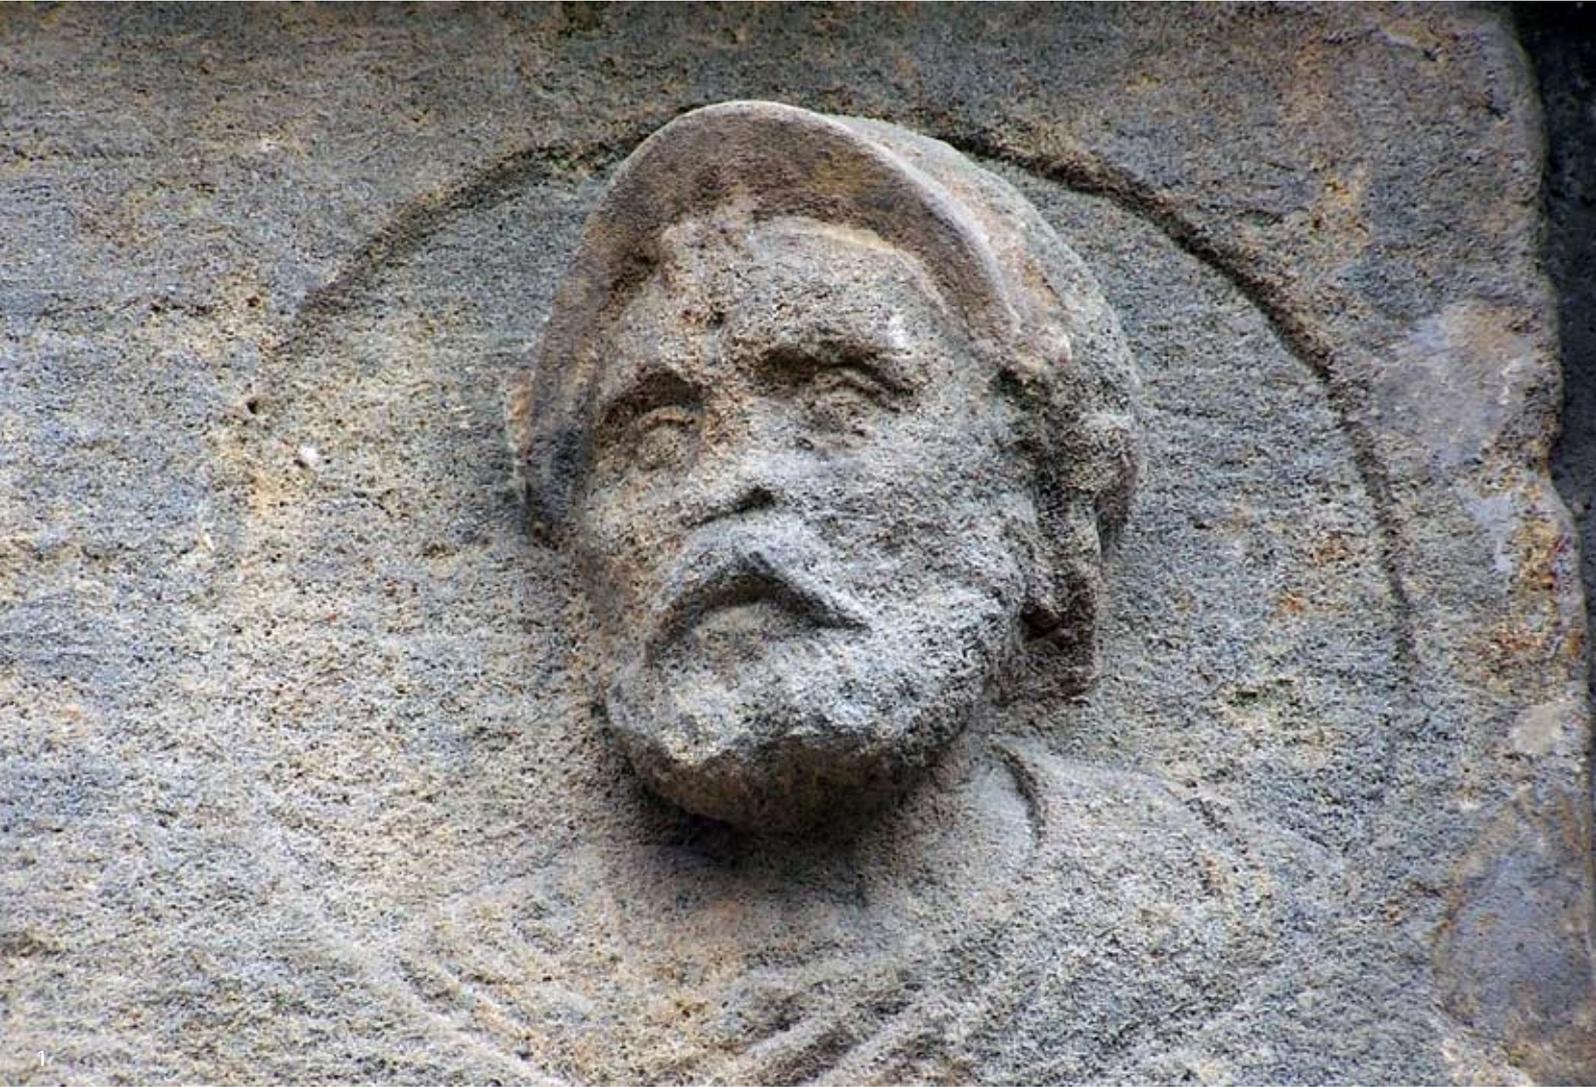
Fig. 1 - Portrait medallion with warrior, break-out on helmet patched with stone repair compound

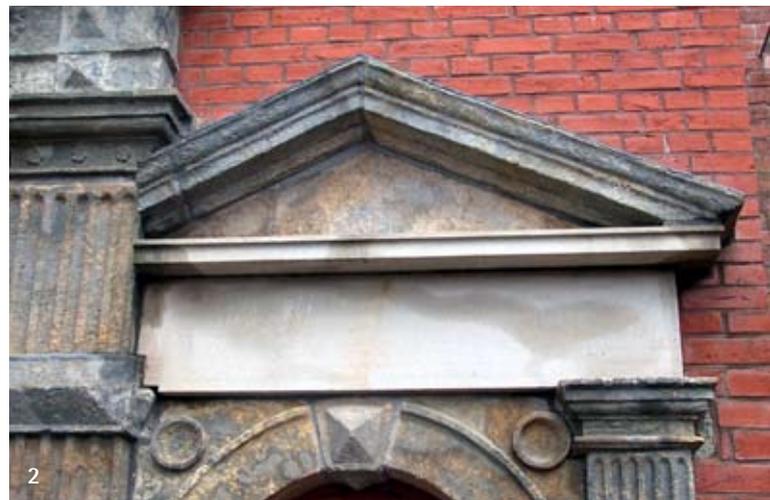
Fig. 2 - Pediment over side entrance

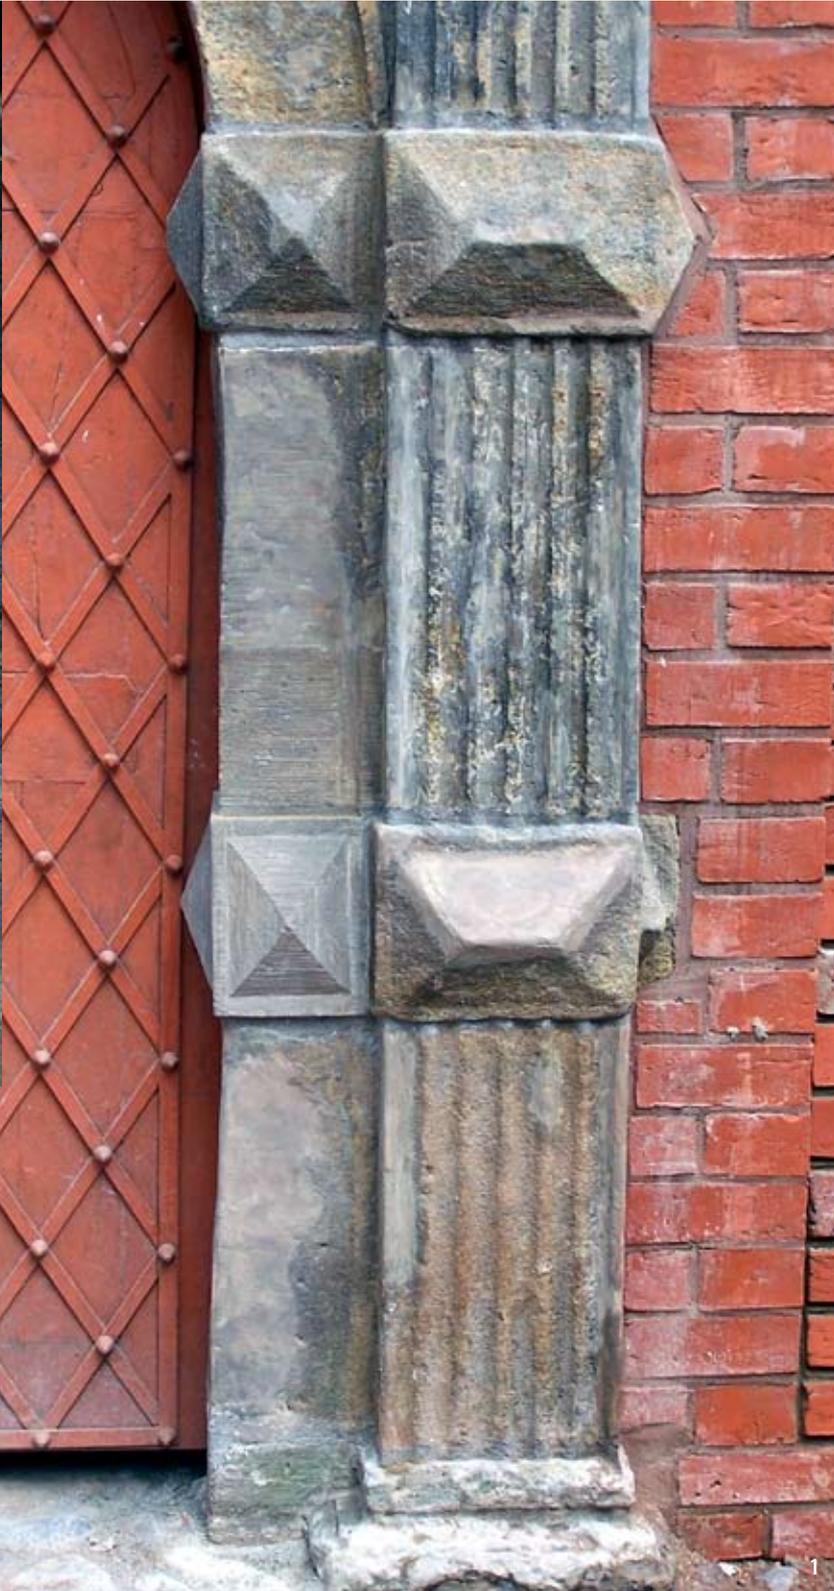
Fig. 1 - Side entrance jamb
