Fortress Dömitz

STRUCTURAL ELEMENT: SANDSTONE PORTAL

Documentation of a Restoration and Repair Project

Baltic Fort Route

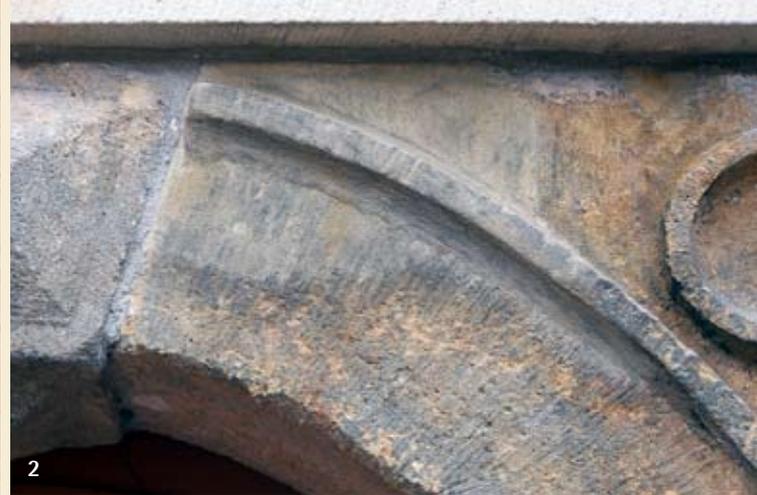
Fig. 2 - Patch with stone repair compound on side entrance arch
